**Report on Potential Environmental Aspects of Renovations
done by the Forest Department
along the road leading from the ticket counter to the
Doranaela-Wathurawa Entrance to the
Sinharaja World Heritage Site & Core Zone of the
Sinharaja Biosphere Reserve**

by
Prof. I A U N Gunatilleke and Dr Jinie Dela
(former members of the National Man and the Biosphere Committee)

Following review visit undertaken on 22nd January 2019

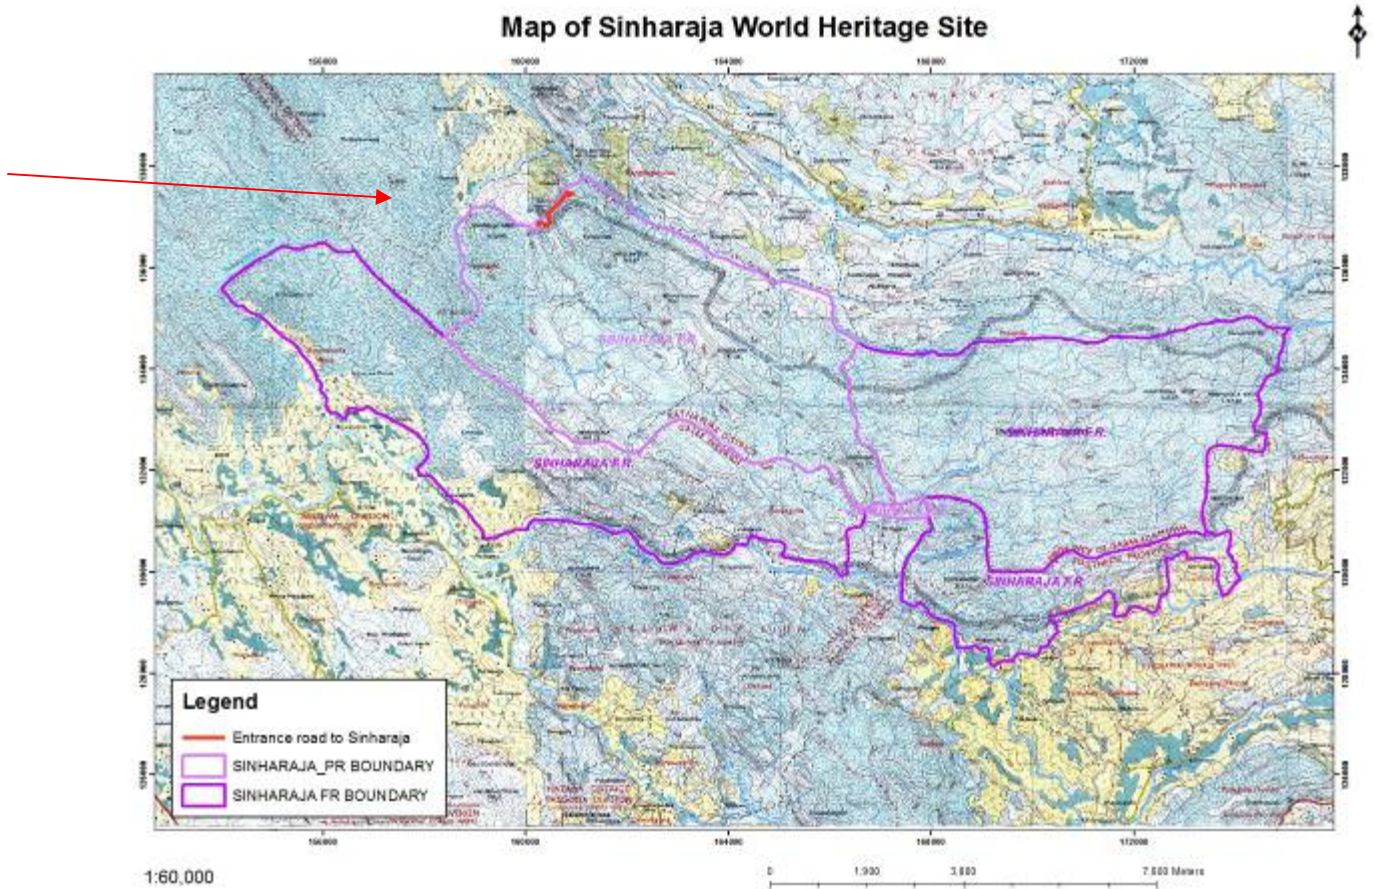
Figure 1a: Map of the Sinharaja Forest with road being renovated depicted by a Red Line
(Map provided by the Forest Department)

2. Figure 1a indicates that the road being repaired is on the outside of the boundary of the Sinharaja World Heritage Site and the Core Zone of the Sinharaja Biosphere Reserve. This road was originally built for the Sinharaja mechanized logging project (Photo 1) in accordance with the Forest Department's felling rules leaving a stream reservation for the Dorana eli.

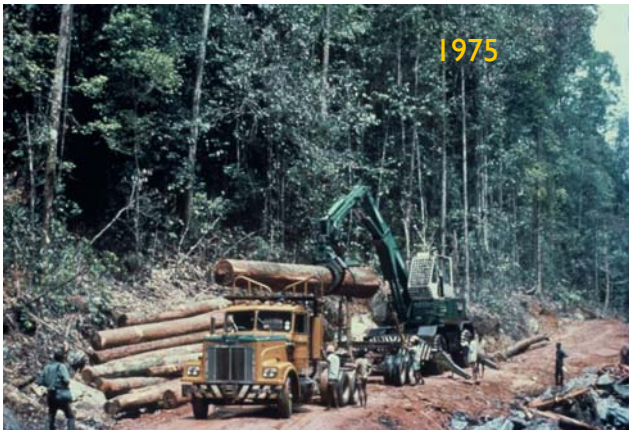
Photo 1: A 20 ft. wide logging road was built during the Canadian-funded mechanized logging project for log haulage by Hey's trucks (21.25 ton capacity 230 h.p.) (Source: Prof IAUN Gunatilleke)

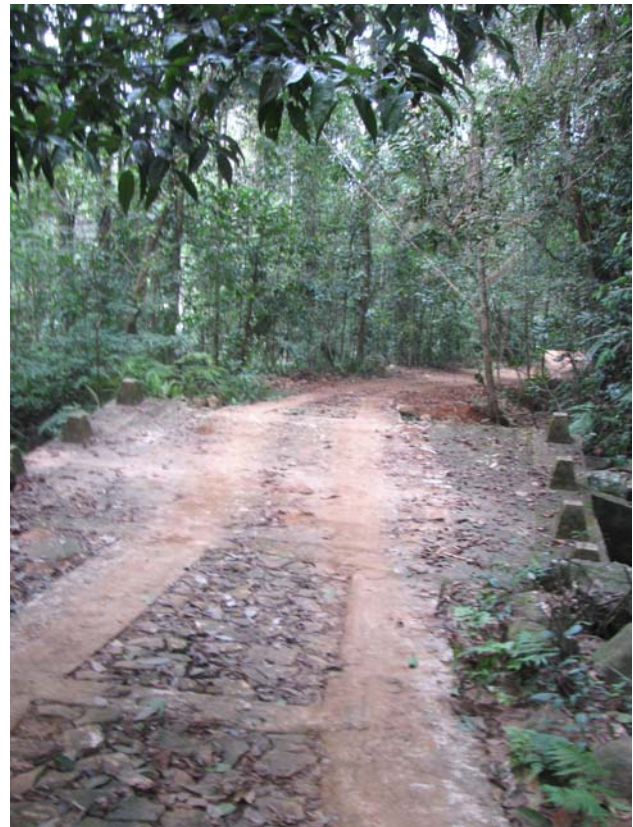
Photo 2: Concreted road and road widening in early 2000 (Photo: Prof IAUN Gunatilleke)

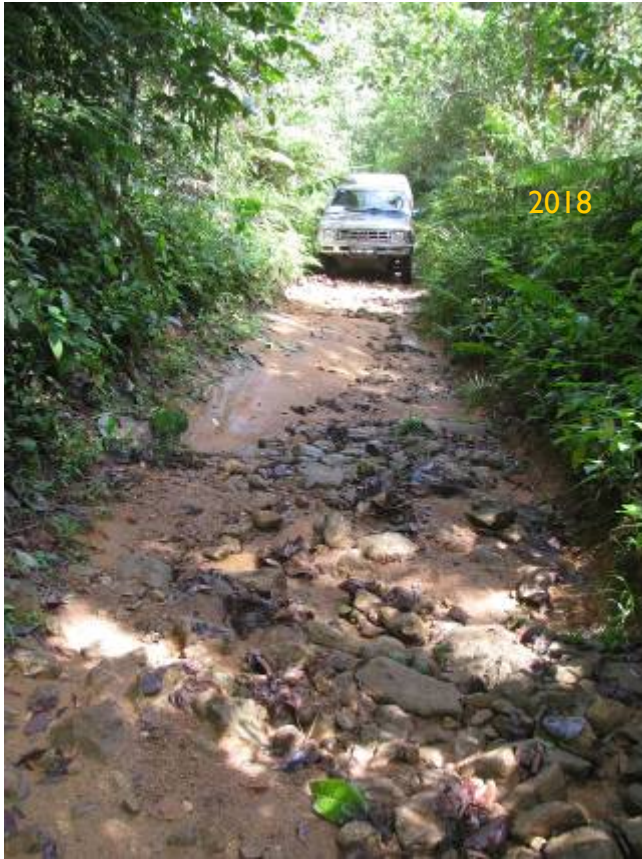
Photo 4: Badly eroded sections of the road in 2018 prior to renovation (Photo: Prof IAUN Gunatilleke)

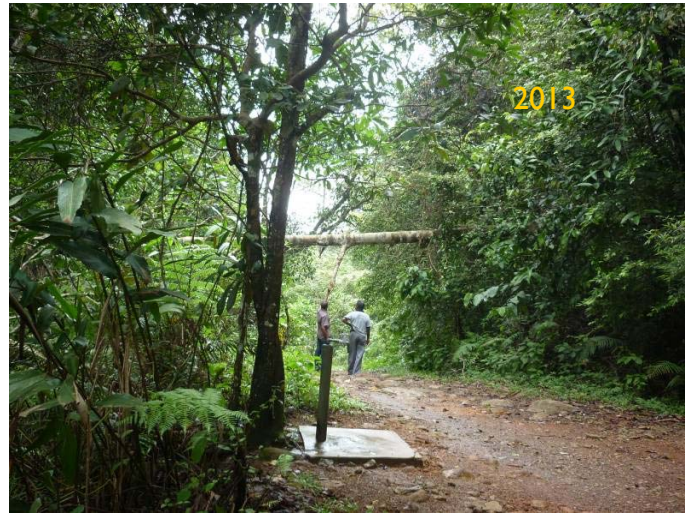
Photo 3: The road in 2013 during the periodic review of the Sinharaja Biosphere Reserve by Dr Jinie Dela with report submitted to UNESCO
(Source: Dr Jinie Dela)

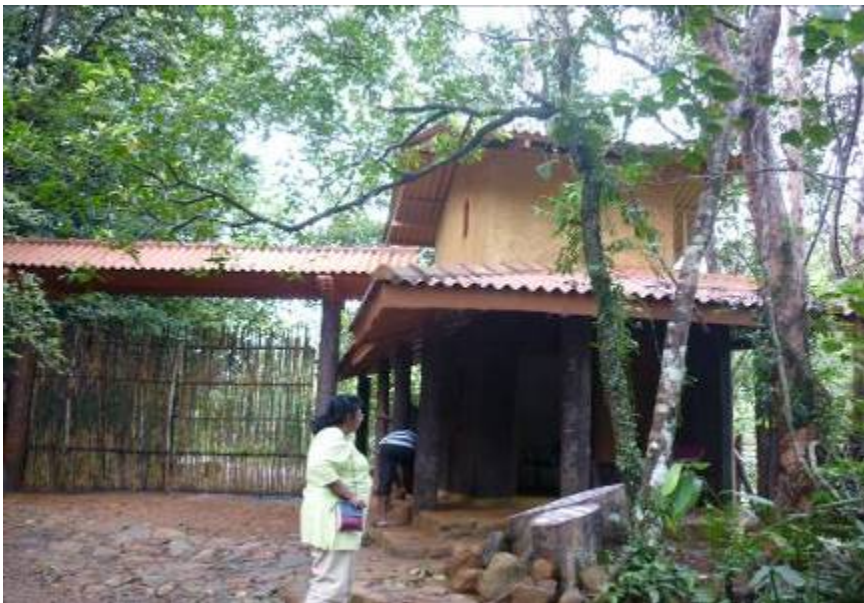
Photo 5: At the entrance to the Sinharaja WHS during the 2013 Periodic Review of the Sinharaja Man and Biosphere Reserve carried out by Dr J D S Dela for the National MAB Committee for submission to UNESCO
(Source: Dr Jinie Dela)

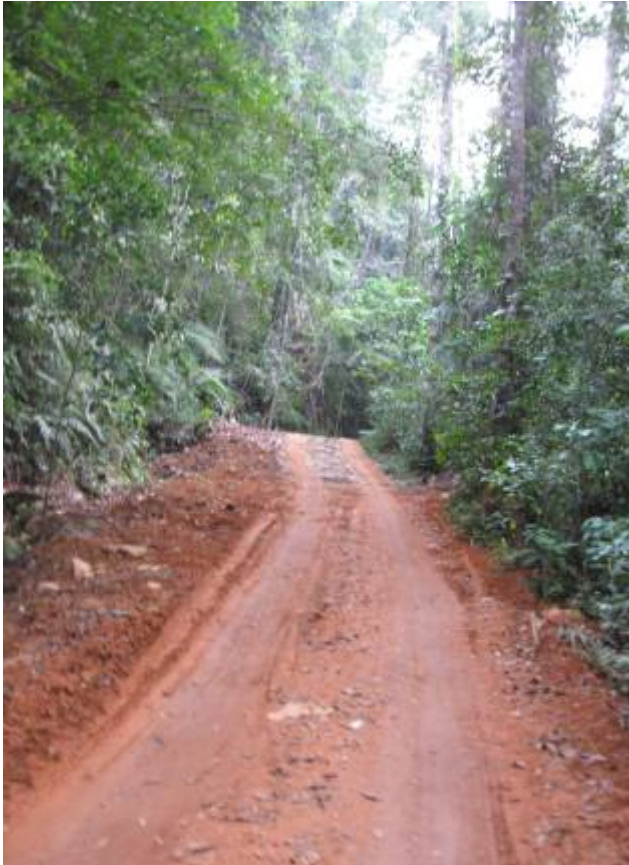
Photo 6: Existing road renovations with ESCAMP funds –2019
(Photo Prof IAUN Gunatilleke)

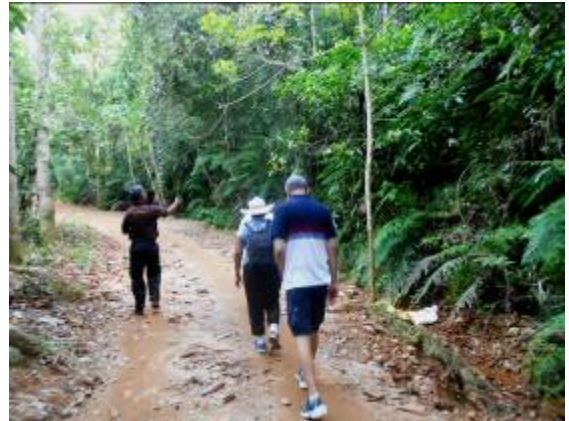
Photos 7: The road during the January 22nd visit

Photos 7, 8 & 9: Inspecting the road renovations done with ESCAMP funds – 2019 (Source: Dr Jinie Dela, photos taken during the review on 22nd January 2019)

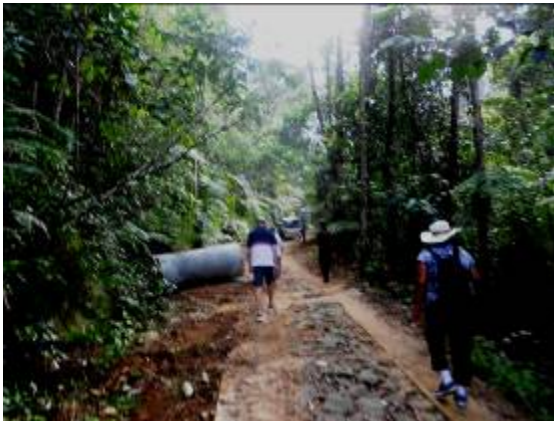
Photos 8: The road during January 2019
